International Journal of Research in Business Studies and Management Volume 4, Issue 1, January 2017, 37-46 ISSN 2394-5923 (Print) & ISSN 2394-5931 (Online) http://dx.doi.org/10.22259/iirbsm.0401005

Collapse of Trust – Moulivakkam Twin Towers

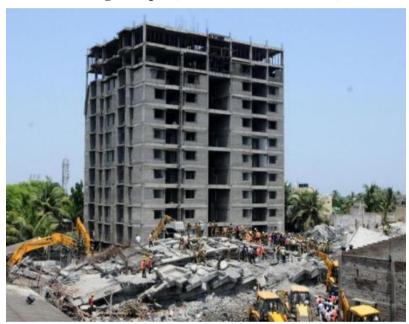
The 2014 Moulivakkam Building Collapse (Source: architexturez.net)

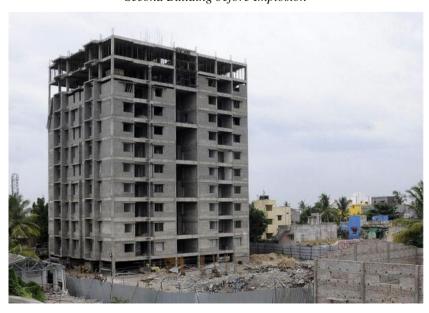
Second Building before Implosion

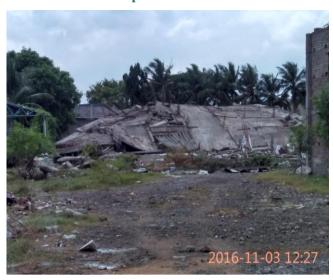
Second Building in Rubbles after Implosion
